SUBJECT: Jackson Hole, Wyoming, Upper Snake River Restoration Project: Request for ASA(CW) Concurrence – Sponsor Credit for Work Performed Prior to Signing of Project Cooperation Agreement

Snake River at Jackson Hole  
**CROSS-SECTION LOCATIONS**  
AREA 9

## **Snake River Restoration Demonstration Project #99-068**

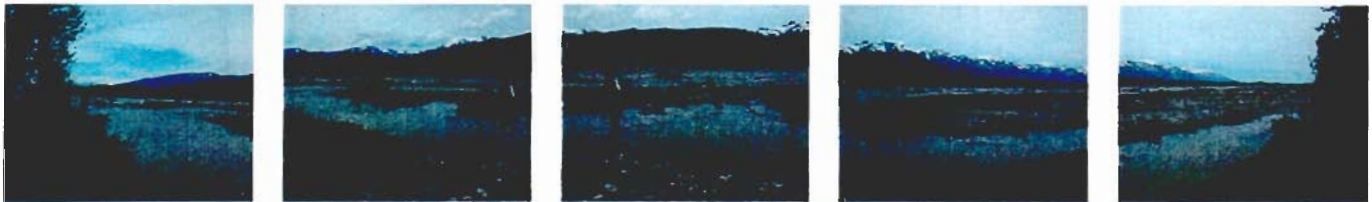
6/4/99

This set of three panoramas is the upper part of the brush fence area and provides evidence of how well the fences captured silt. The first series was taken at river flows of 15,900 cubic feet per second. The water had only appeared the day before in the fenced area and is "subbing" up e.g. ground water pooling at this point. Note the distance the main channel of the river is from the end of the fences. At low flow the edge of the channel was at least 40 meters from the fence in this location.

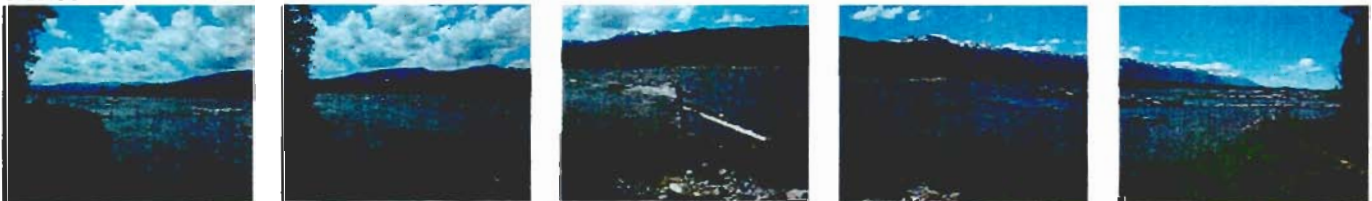
6/25/99

The second series (17,200 cfs) was taken the first day after peak runoff that the site could be accessed (20,600 at 6/18/99). The fenced area has had river flows passing through for about 15 days at this point. Note that heavy current impinging on the end of the fence at left and that the main channel of the river is trying to shift into the fenced area but is being diverted away by the fences.

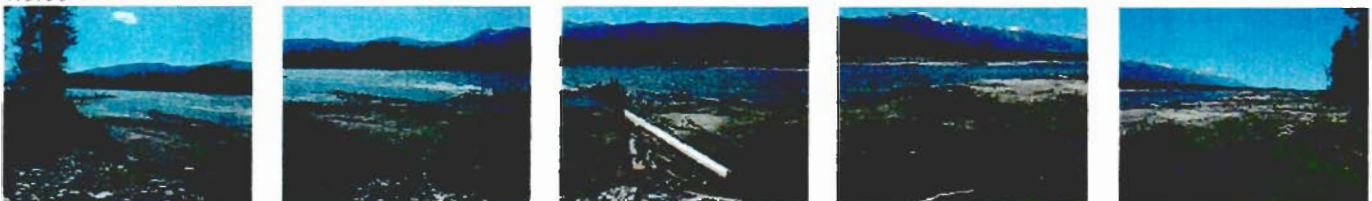
7/9/99

Spring runoff flows have receded to 8,800 cfs in this series. Significant deposition of nutrient rich sediment has occurred with the fences functioning as expected. However, the fences were not designed to withstand a direct attack from such high velocities as was experienced during this event which were up to 15 feet per second in this case. Prior to runoff, the main channel of the river was well out from the fenced area. As you compare this series with that taken on June 6<sup>th</sup> you can see that the main channel has completely shifted from river right to river left. Consequently, had the fences not been in place the lower third of this island would have been attacked by the main current and would have been eroded away. To have the fences function as island protection was an unanticipated bonus.

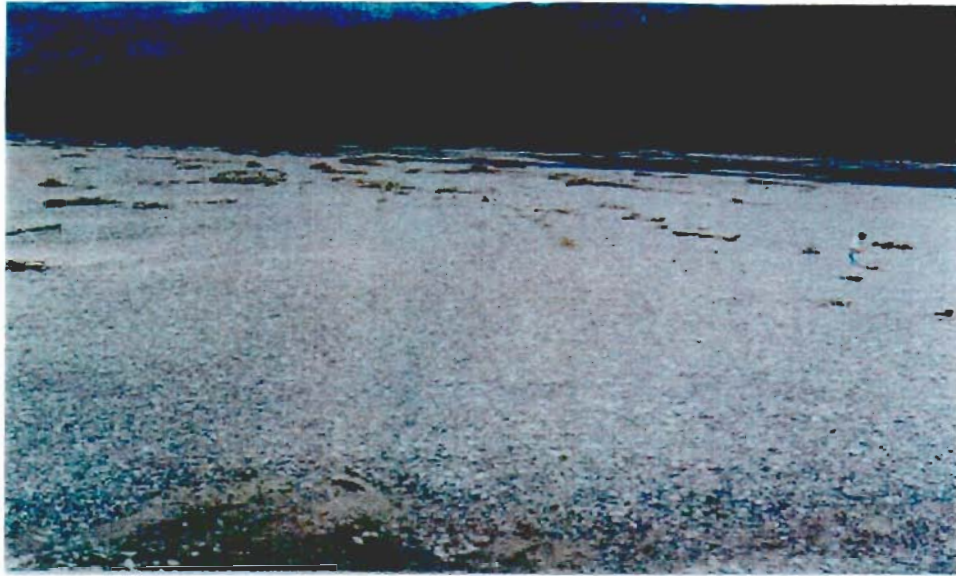
*Aggradation of bedload material as indicated here was occurring in a number of areas along the leveed reach. Most notably in the Gros Ventre / Snake River confluence, at the Snake River Bridge, and at the lower end of the leveed reach.*

It has been established through sediment range surveys first completed in 1954 that there are several sites along Snake River's levee reach that have experienced excessive aggradation of bedload material. This aggradation causes severe channel instability and diminished flood capacity in these areas.

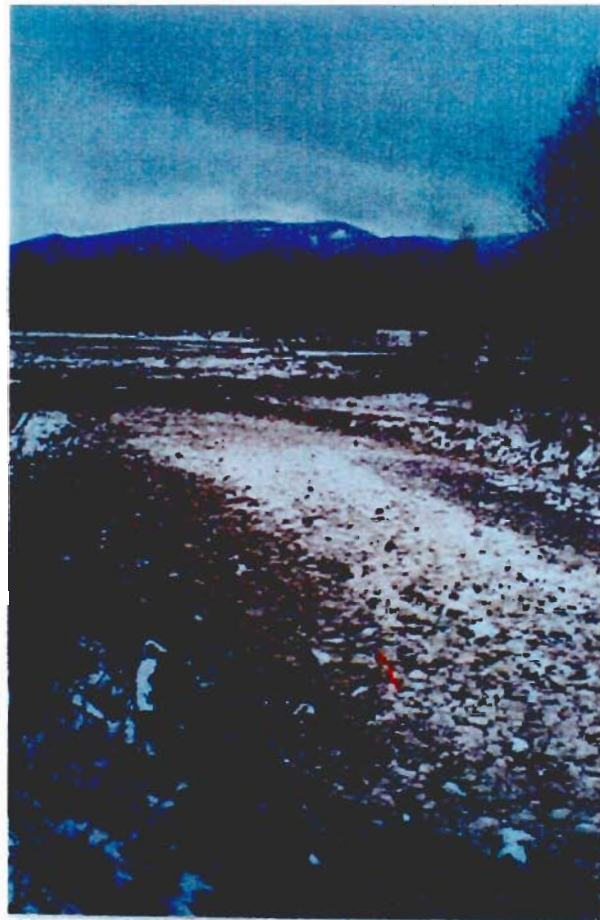
*The site pictured above is of the lower pool at the end of an abandoned channel*

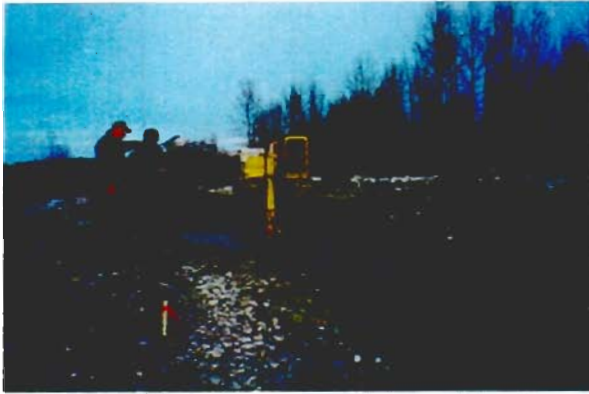
*Corps of Engineers personnel supervising the excavation of the lower pool*

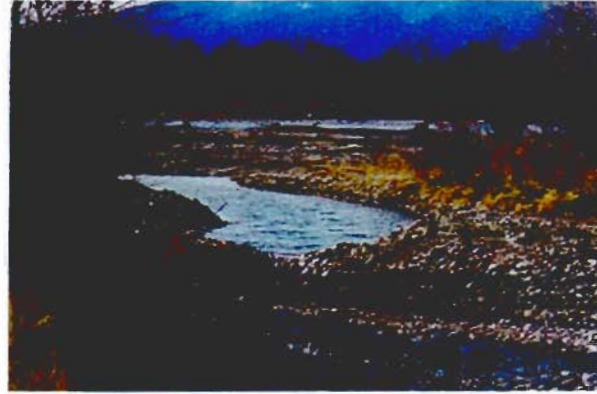
*Completed lower pool prior to runoff*

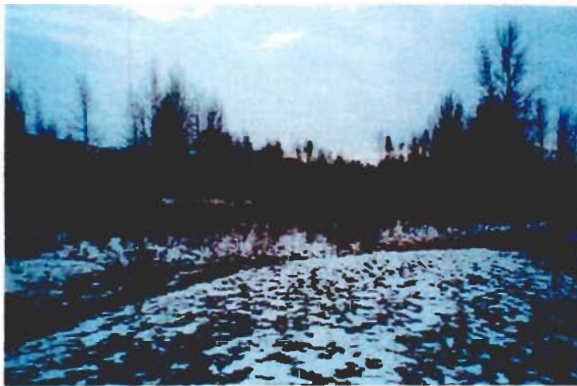
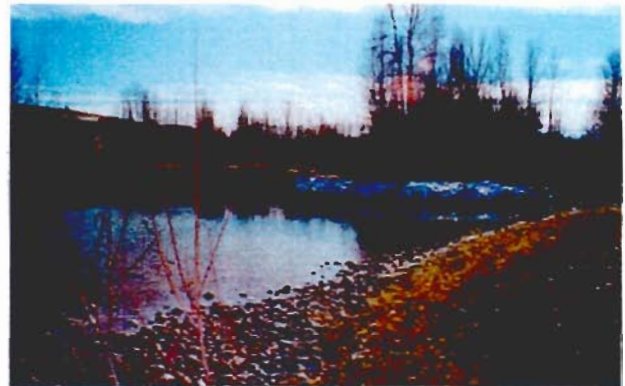
*These "before and after" photos are of the middle pool area. This area is about midway down the secondary overflow channel on the island. The water shown in the left photo appeared during excavation and is being supplied by groundwater percolation. This minimal level was sustained throughout the winter.*

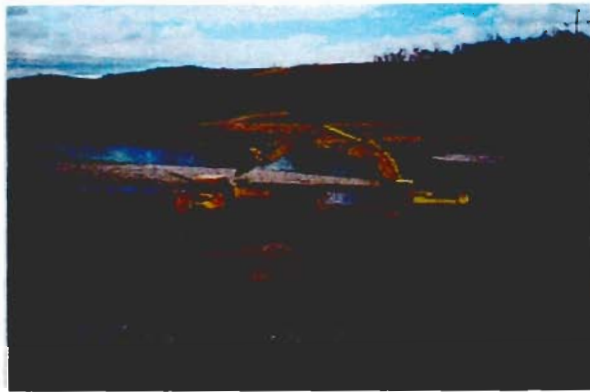
*After the material was removed from under the bridge, the operation moved upstream to some of the larger gravel bars.*

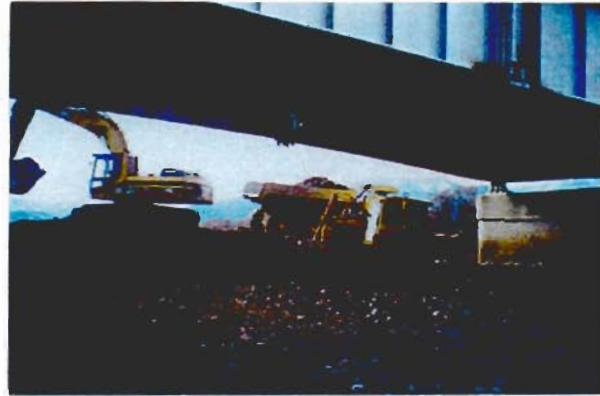
*Channel management activity required additional heavy equipment in the immediate area of the Wilson Bridge. Aggradation of material was so excessive that the riverbed was lowered up to thirteen feet in this area. A small bulldozer was used to push the material out to the backhoe so that it could be loaded into the dump trucks*

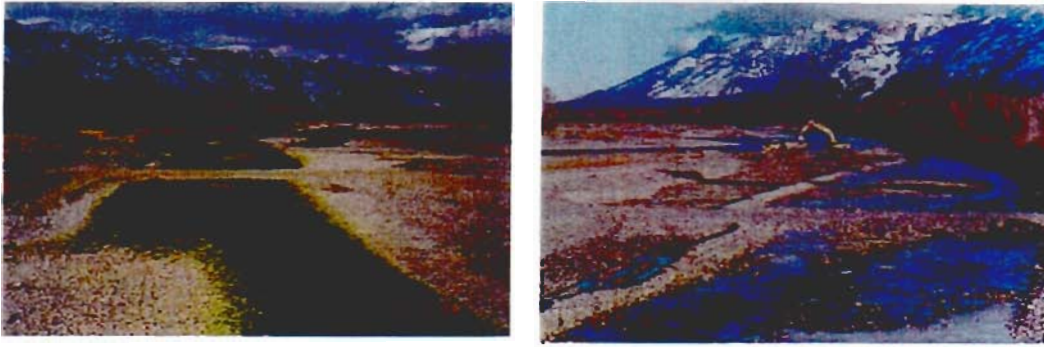
*The process of gradual dewatering one half of the excavation at a time provided a method of extracting bedload material "in the dry" while minimally impacting water quality and existing fish populations.*

To accommodate the special conditions of the 404 permit and to address concerns of the Department of Environmental Quality and the Wyoming Game & Fish Department, the excavation of the channel was accomplished in two phases. The first phase included the installation of a 36" corrugated metal pipe to accommodate an existing flow in a side channel of approximately 100 cfs that was on the west bank of the river. The placement of the pipe served several purposes. It allowed for dry access to the eastern side of the excavation while allowing for a continued flow through the side channel in case fish were present. Once the pipe was in place the flow was then reduced to approximately 25 cfs by the placement of rock in the upper inlet of the side channel. This measure incrementally dewatered a majority of the side channel thereby insuring all work would take place in the dry, while allowing for a minimum flow necessary (and minimal impact) for any aquatic organisms present.

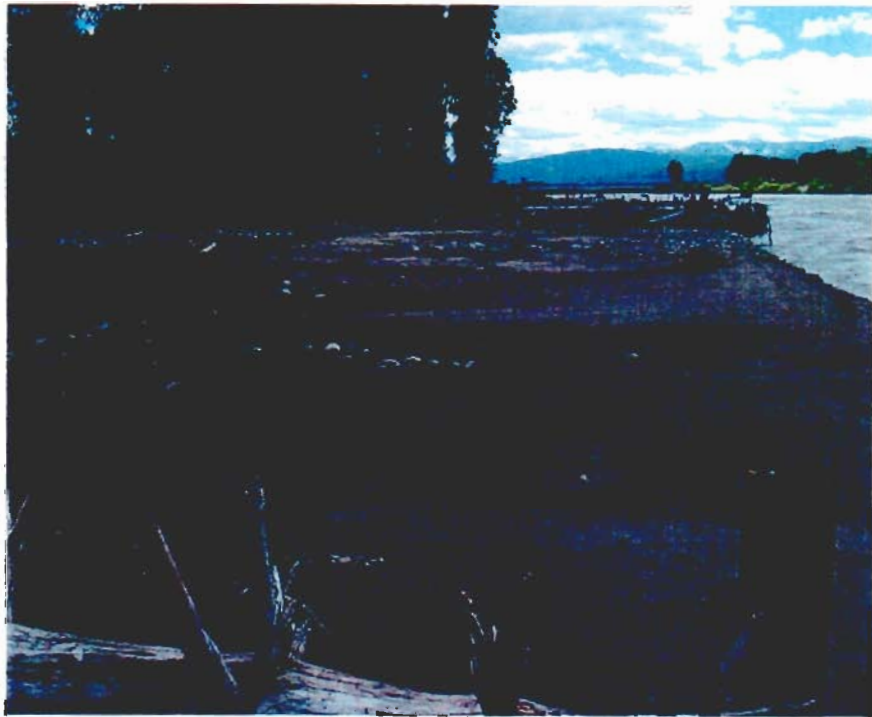
*Prior to the 1999 runoff event this area was composed primarily of cobble and gravels. Post runoff observations reveal that silts and nutrient rich sediments were deposited.*

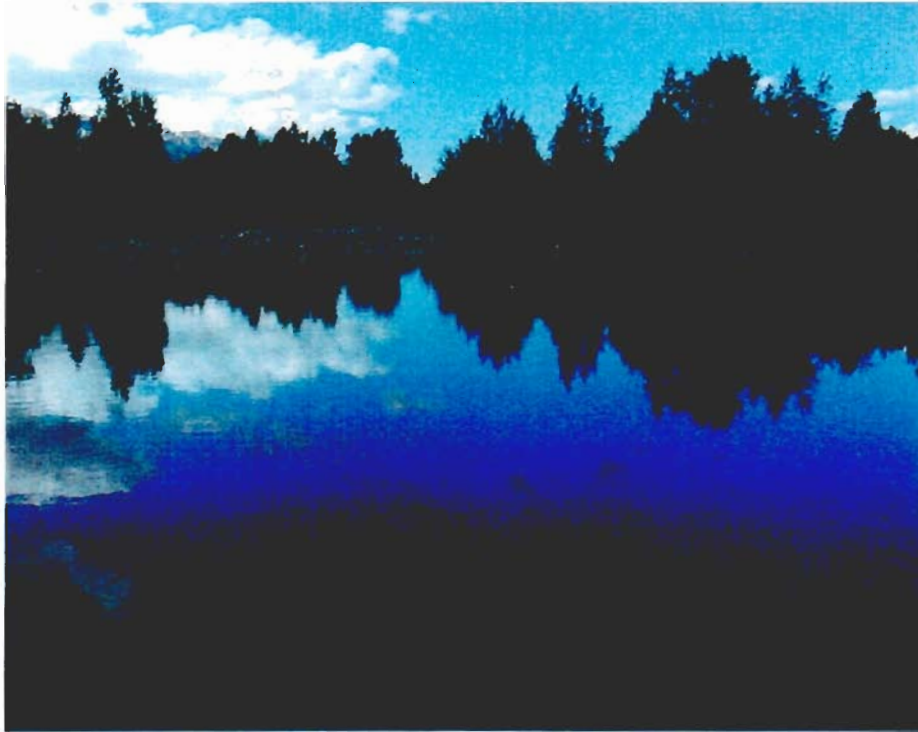
*Upper Pool nine months after construction.*

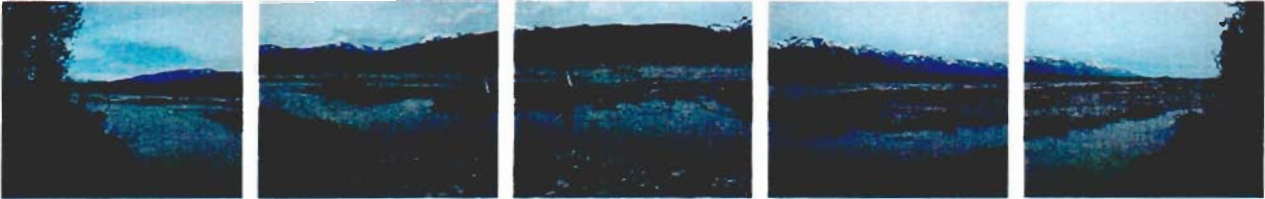
6/4/99

The upper part of the brush fence area provides solid evidence of its ability to capture silt. The first series was taken at river flows of 15,900 cubic feet per second. Water had first appeared the day before in the fenced area and is "subbing" up e.g. ground water pooling at this point. Note the distance the main channel of the river is from the end of the fences. At low flow the edge of the channel was at least 40 meters out from the fence in this location.

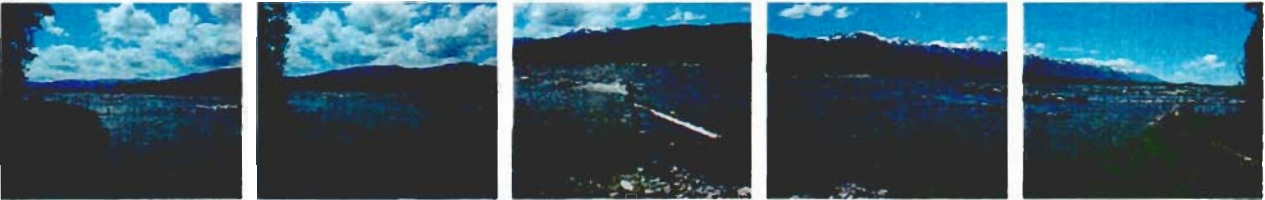
6/25/99

The second series (17,200 cfs) was taken the first day that the site could be accessed after peak runoff (20,600 at 6/18/99). The fenced area has had river flows passing through for about 15 days at this point. Note the heavy current impinging on the end of the fence at left and the main channel of the river moving into the fenced area but being diverting back away by the fences.

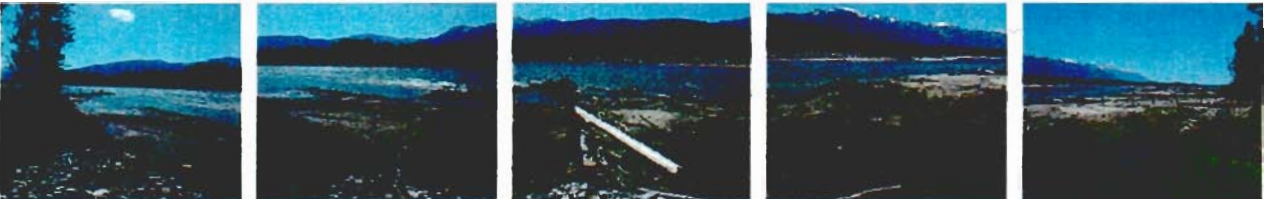
7/9/99

Spring runoff flows have receded to 8,800 cfs in this series. Significant deposition of nutrient rich sediment (up to 18" in most areas) has occurred with the fences functioning as expected.

While the debris fences functioned as expected, they also provided an unanticipated level of direct protection to the area. Not intentionally designed to endure a direct impingement from high velocities, up to 15 feet per second in this case, they performed beyond expectation. Prior to runoff the closest edge of the main channel of the river was 40 meters from the fenced area. During runoff the main channel shifted from river right to river left entering the fenced area from the side rather than from upstream. Acting like kicker dikes, the fences kept the main energy of the flow away from the island. While there was some damage to several of the fences, (four of the outer posts (6" well casing) were bent in half) if they had not been in place there is a high probability that the lower one third of the island would have been destroyed.

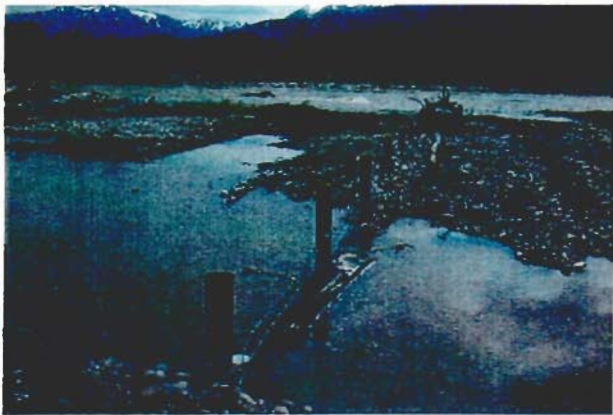
The photo at left illustrates the typical composition of the riverbed in the area of the debris fences prior to runoff. Cobble and gravels constitute the majority with some sand and a little silt. The vegetation is comprised of cool climate grasses and weeds.

This photograph at right, taken June 21st @ 19,600 cfs, shows the fences underwater. The flow at upper end of the fenced area did not have significant velocity, estimated at 2 feet per second. The middle and lower end however experienced high energy impingement, estimated between 10 – 15 feet per second as the main channel avulsed toward the island. You can see the standing waves created by fences three and four near the center of the photo.

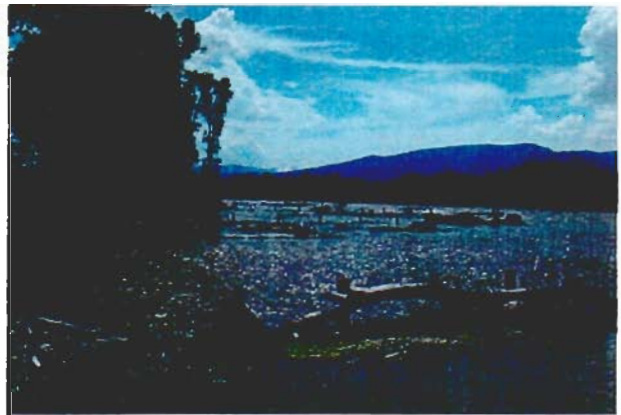
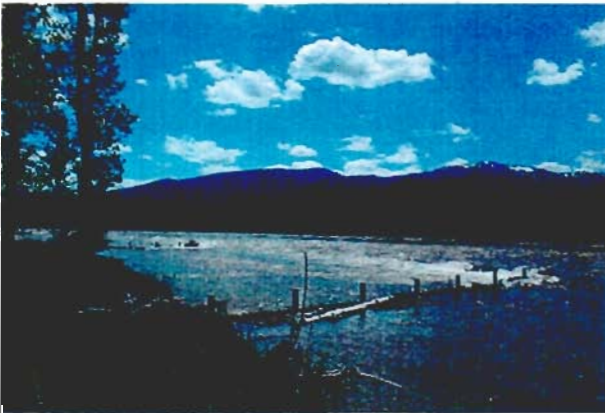
Debris fences # three and four at left are acting similar to kicker dikes and deflecting the main energy of the flow (19,000 cfs) away from the island. The hydraulic "head" created by the debris lodged in the fences and impeding flow through the fence and creating "back pressure" was responsible for keeping the flow from entering the area in between the fences.

This is a good representation of the type of material captured by the fences. Note the deep scour hole at the end of the fence. While the end of this fence was damaged from the high flow, the result created excellent fish habitat.

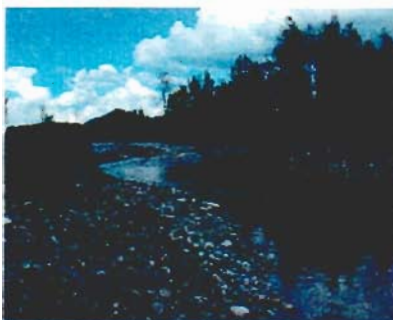
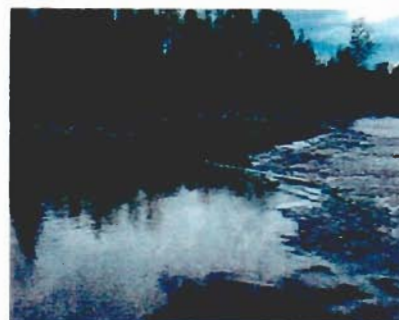
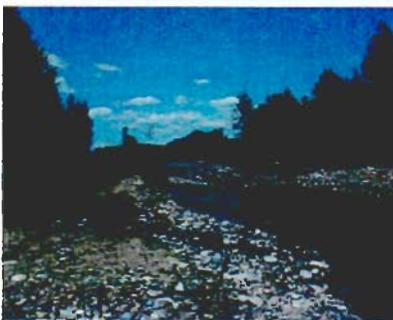
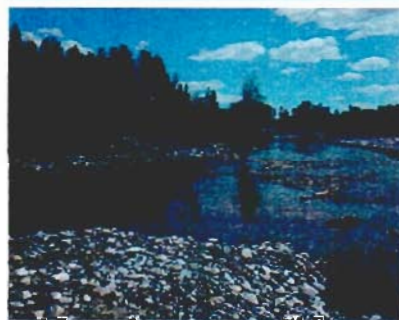
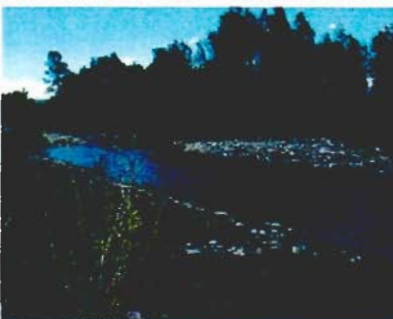
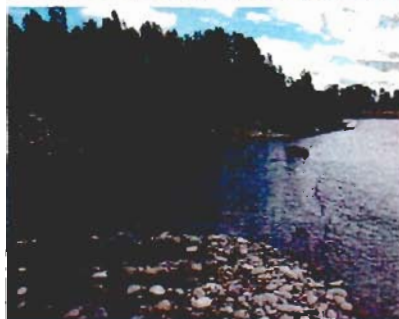
### Lower Pool Study Photos

While the lower pool was transformed by erosion early in the runoff period on the lower end into a back eddy by the main river for several weeks, when the river levels dropped a natural coffer dam formed and an adequate water elevation was retained in the pool. The middle pool's configuration did not change although some deposition of sediment occurred during runoff. While there was no direct inlet to the upper pool, during high water outflow discharge was observed as high as 3 – 4 cfs. There was no turbidity observed in this pool at any time. Please refer to field notes on the following page.
